Manhole Inspection Summary

Manhole # S47A__023MH

Insp Date: **6/11/08 1:47 PM**

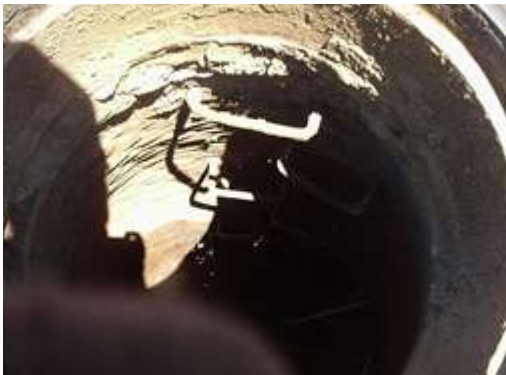
Defect 1

deterioration

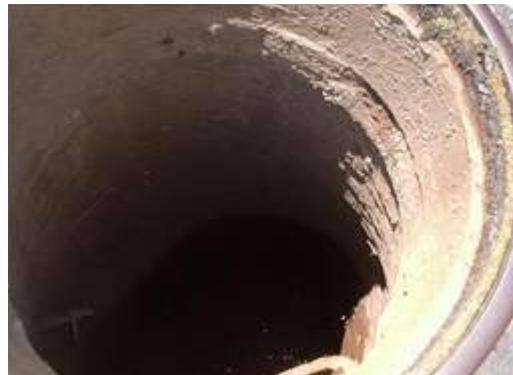
Defect 2

☒ **Leaks**

frame leaks

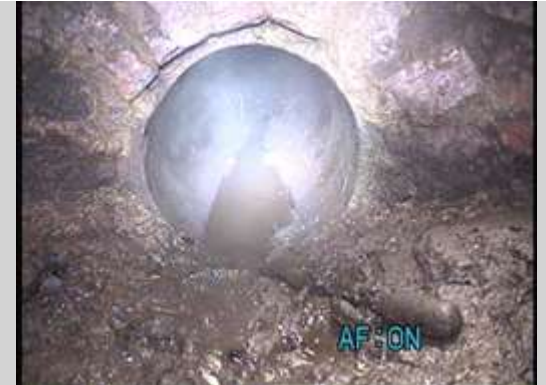
12 O'Clock Outflow

8 in. Circular Gravity Sewer
Pipe Out @ 12 O'Clock

Pipe Height: **8.4** (in.) Rod and Bar (Angled)

Pipe Material: **Clay** ☐ Pipe Lined

Invert Depth: **9.70** (ft.) Flow Characteristics: **None**

Deposits: ☒ None ☐ Mud ☐ Sludge ☐ Debris ☐ Grease

Infiltration: **None** Pipe Seal Cond: **Sound**
